Channel Infrastructure NZ

# Marsden Point Refinery Recommissioning Study

Cost Estimate Report

310515 - RPT - X0001  
September 2024

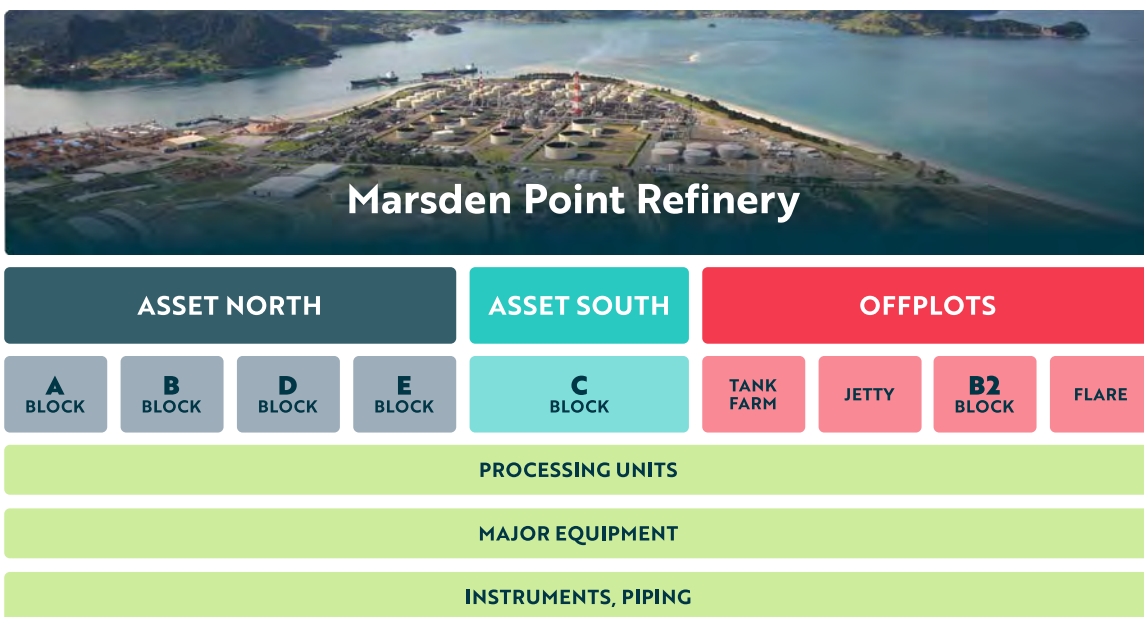
Figure 1: Overview of the Existing Asset Hierarchy.

In general, the Marsden Point facilities were broken down into three main areas, Asset North, South and Offplots. The refining plant was located in Assets North and South each comprising of blocks and respective individual units. This study has utilized the existing asset hierarchy as the work breakdown structure and is summarised below in Figure 1. A detailed list of all process units reviewed by this study and their respective age is detailed in Appendix B.

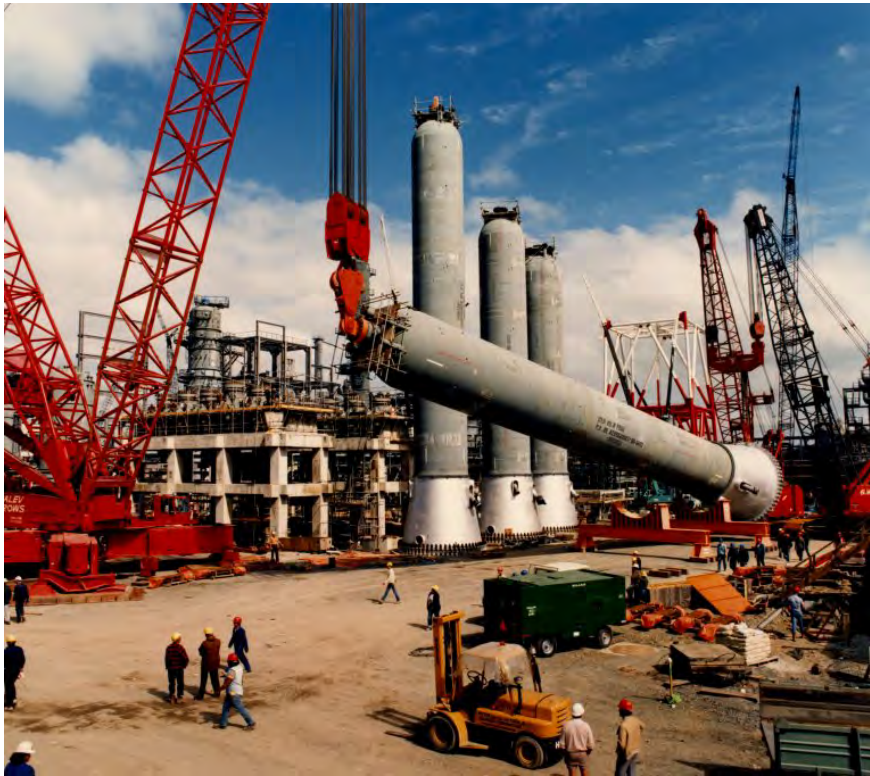
Figure 2: Hydrocracker R-7502 being lifted into place during the 1980's Refinery Expansion. Photo courtesy of: <https://channelnz.com/who-we-are/our-history/>

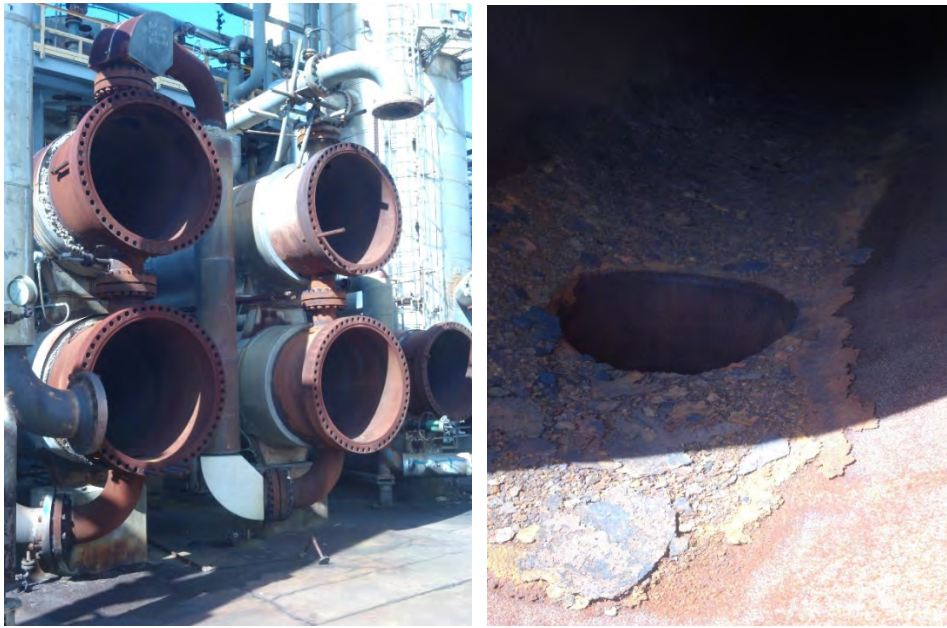
The equipment has now been open to the atmosphere for over 2 years and given the location of the plant relative to the ocean, internal corrosion is inevitable. Some areas of the plant are made from stainless materials which may somewhat mitigate the corrosion risk although, they are still susceptible to other failure mechanisms such as Stress Chloride Cracking (SCC), which could present should the plant be restarted. Significant repairs and refurbishments are likely to be required as a result of the plant being left open to the atmosphere over this timeframe.

*Figure 4: Example of Rust Scale build-up within Exchanger Shells in the 250-unit. – 20/08/24.*

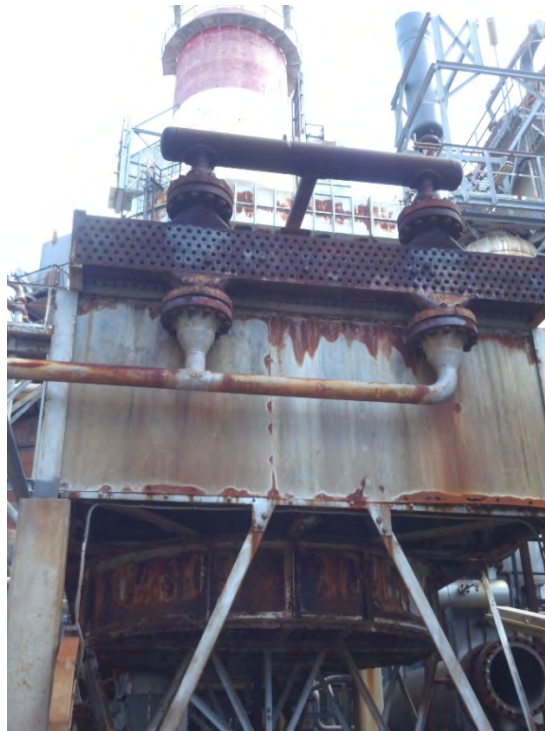
- All packed beds removed have been recycled and will require replacement.
  - Vessel demisters will need to be replaced.
  - Air Cooled heat exchangers (Finfans) have had end plates and plugs removed, thereby exposing the internals of the exchanger to the atmosphere. Inspection techniques such as eddy current that are required to survey the internals of the tubes, these are expensive and typically require specialist resources.

*Figure 5: An Example of a Fanfan Cooler in A-Block showing the Tube Plugs removed and significant corrosion to the fan cowling and header box.*

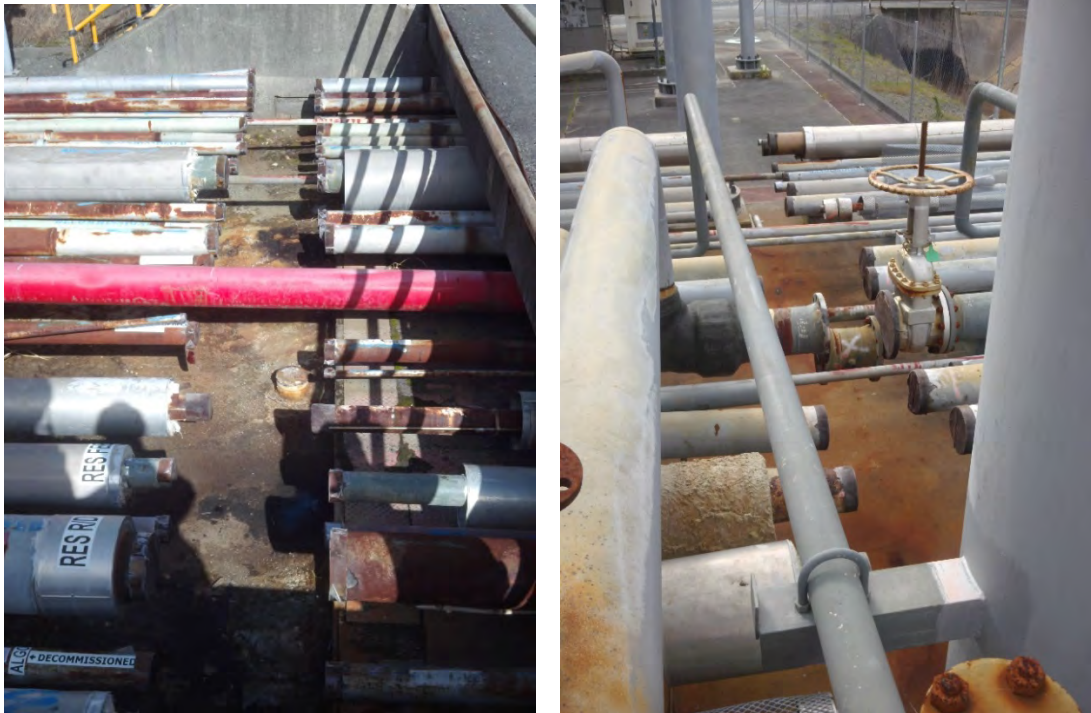
Figure 6: Example of Air-Gapped Piping. Left: A-Block and Off-plots, Right: D-Block and Off plots - 20/08/24

- All piping that has been cut and air gapped will need to be repaired.

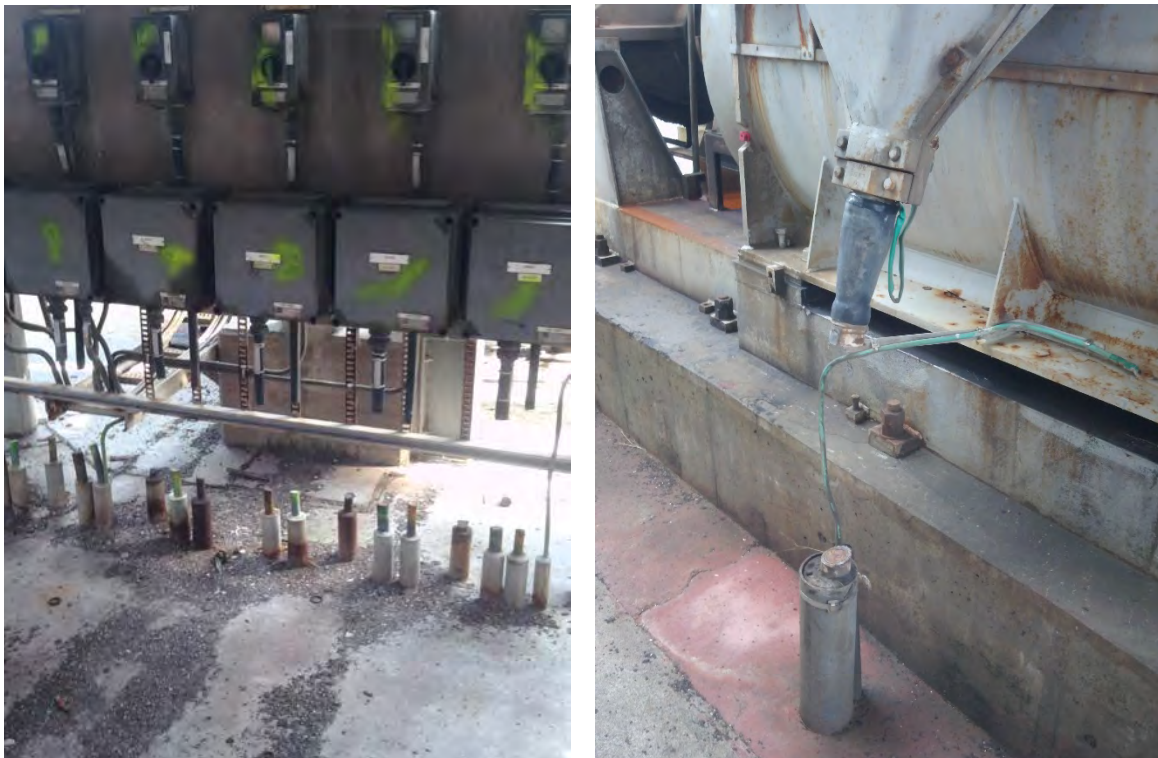
- All electrical and instrument cables between the substations and the refinery have been permanently cut and the ends have been left unsealed open to the atmosphere therefore, degradation of the cable cores is expected.
- As these cut locations are mostly within the hazardous area methods for rejoining these cables is more complex especially given the quantity of joints required. In many cases full cable replacement cables will likely be required.

Figure 7: Typical Example of Cable 'Air-Gapping', Left: Power/Instrument Cables to Hazardous Area Junction Boxes, right: Power Supply to Electric Motor – 20/08/24.

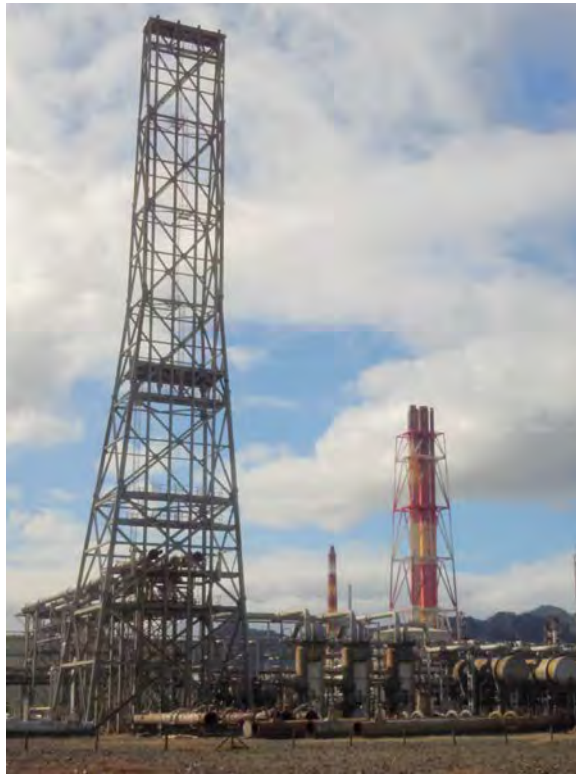
Figure 8: Flare System showing the Elevated Flare sections removed and Disassembled at Grade - 20/08/24.

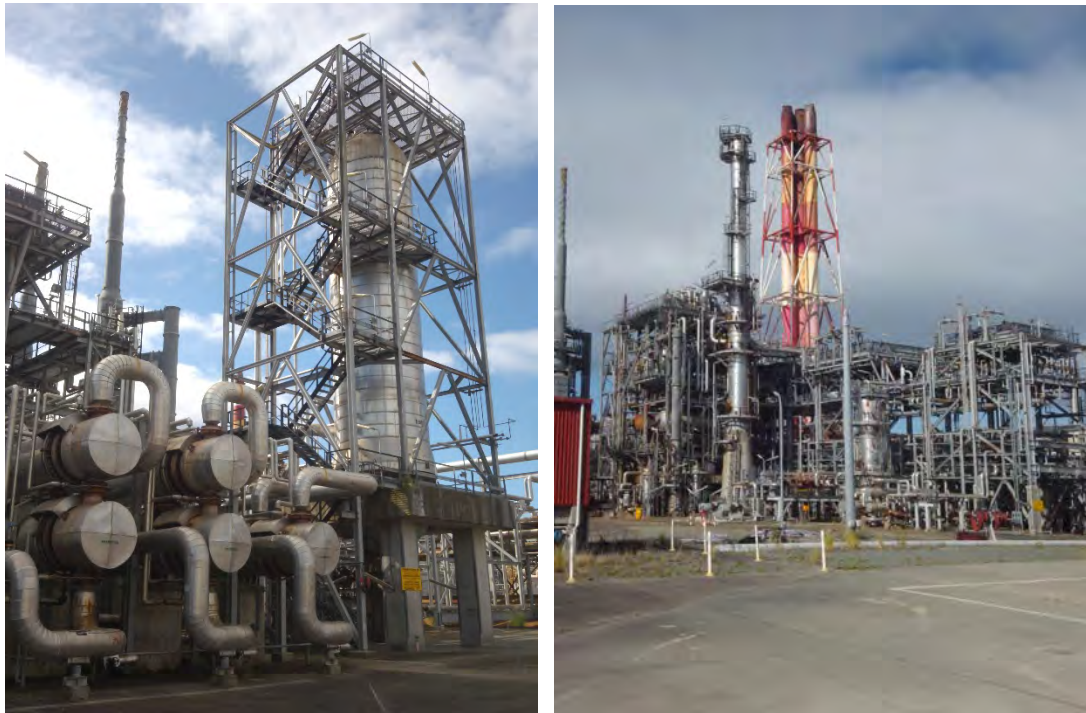
- Exchanger bundles, packed beds and demisters remain installed.
- Equipment such as vessels & columns remain boxed up.
- As in the rest of the plant catalysts have been removed from all Reactors.
- While the piping has been air gapped at the battery limits, the piping is boxed up and under a Nitrogen purge.
- While the cables to the preserved equipment in C-Block have also been cut, the cables in D & E-block remain intact but the power is isolated in the substations.

Figure 9: Typical Example of the Equipment in D-Block. Left: Shell & Tube Exchangers & equipment remains Boxed up. Right: General Photo of D-Block.

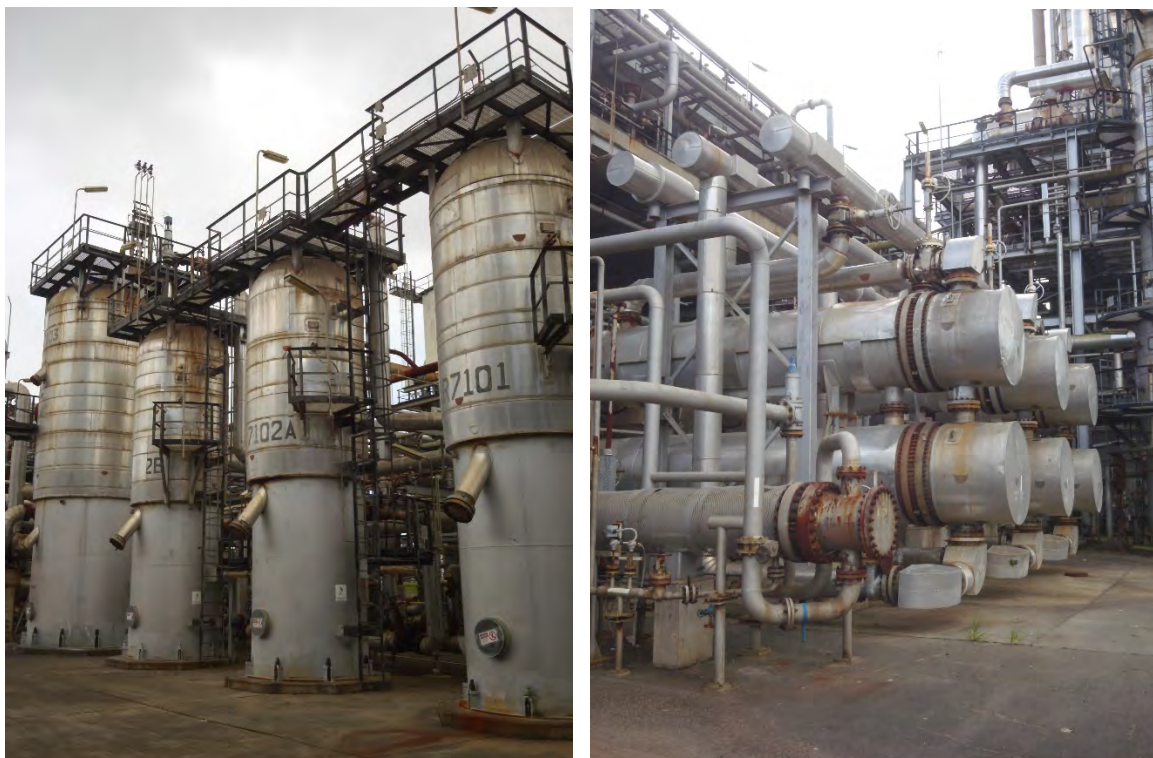
Figure 10: Equipment under Preservation in C-Block. Left: HMU Reactors. Right: ADIP-X Shell & Tube Exchangers remain assembled.

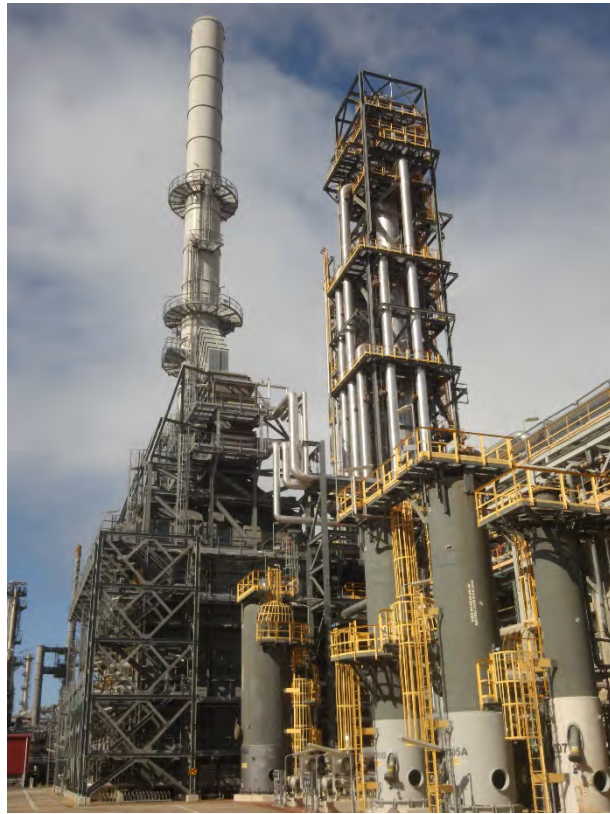
Figure 11: E-Block Commissioned in 2015 remains complete and under a Nitrogen purge.

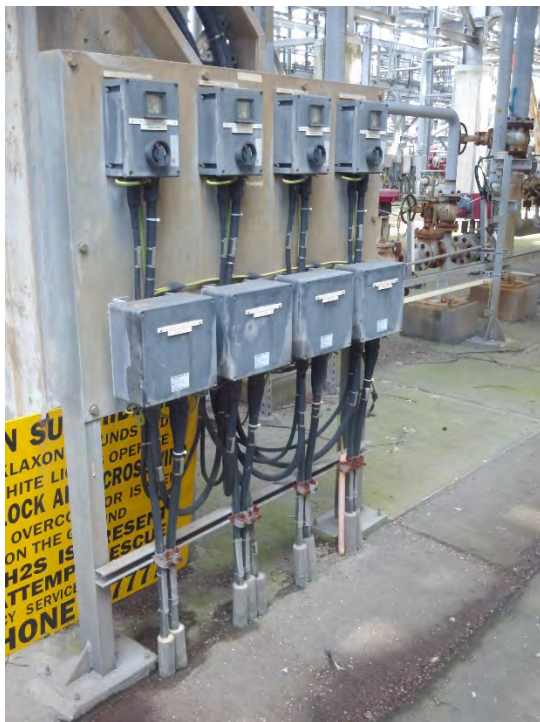
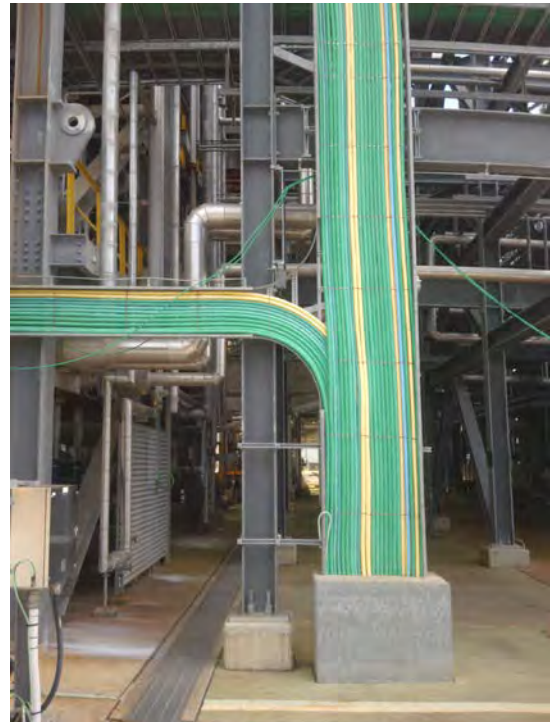
Figure 12: Example of Cables in D-Block (Left) and E-Block (Right) remaining in-situ and in tack.

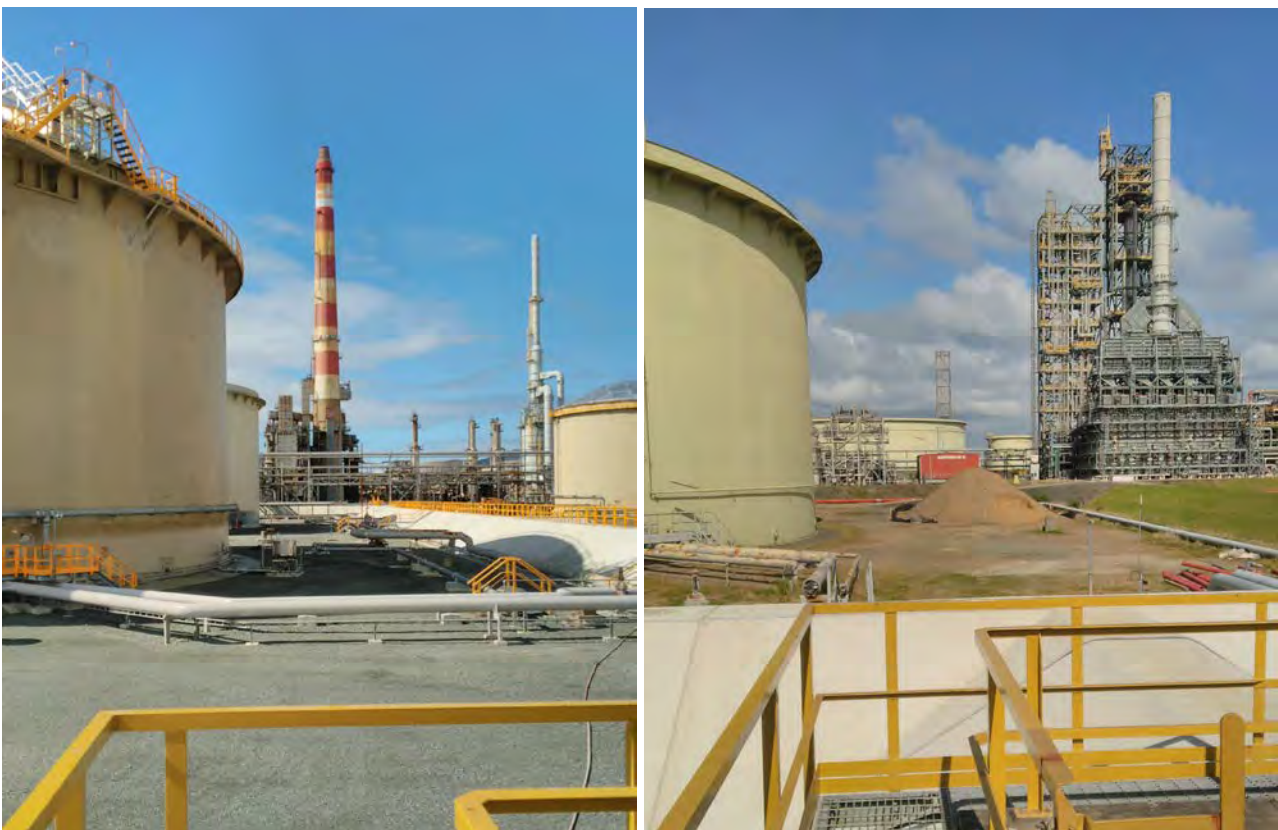
- There are two common compliance upgrades required to bring the existing 1960/1980's standard secondary containment up to the latest NZ regulations; some bunds are insufficient in volume while others have a measured leakage rate that exceeds the allowable requirements.
- The tanks currently in service are being managed under a compliance plan with Worksafe and a campaign of bund upgrades is underway.
- A typical bund upgrade includes significant civil works required to either increase the bund capacity or, excavate and repair or, entirely replace the bund liner.
- Table 6 details the tank compounds that have been upgraded or are in the process of being upgraded. Details of which tank is included under which compound is available in Appendix C.
- Figure 13 below shows a general comparison of a tank compound / bund which has recently been upgraded relative to an existing bund.

Figure 13: An Example of an Upgraded Bund relative to an Existing. Left: Existing Crude T04 Converted to Jet A1 located in the newly upgraded C3 Compound. Right: Crude Tank T05 currently decommissioned, piping can be seen to be removed, secondary containment is no longer compliant.

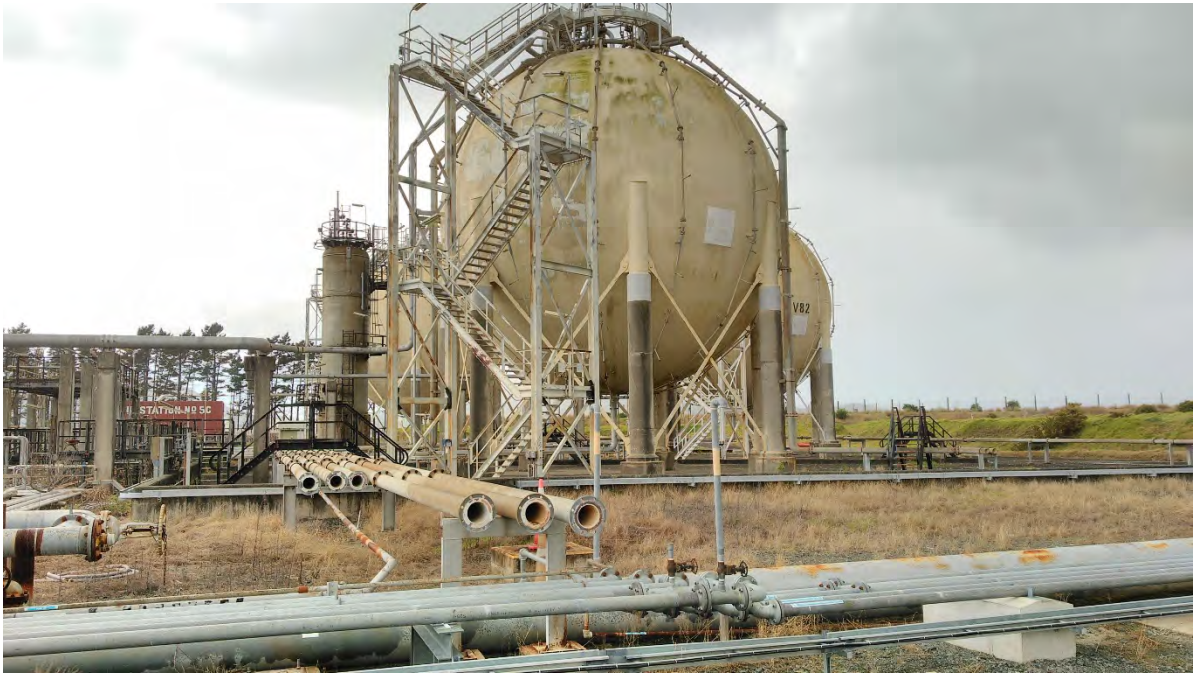
Figure 14: The piping to and from the Butane Sphere's located in the offplot areas has been demolished as part of the conversion to a terminal.

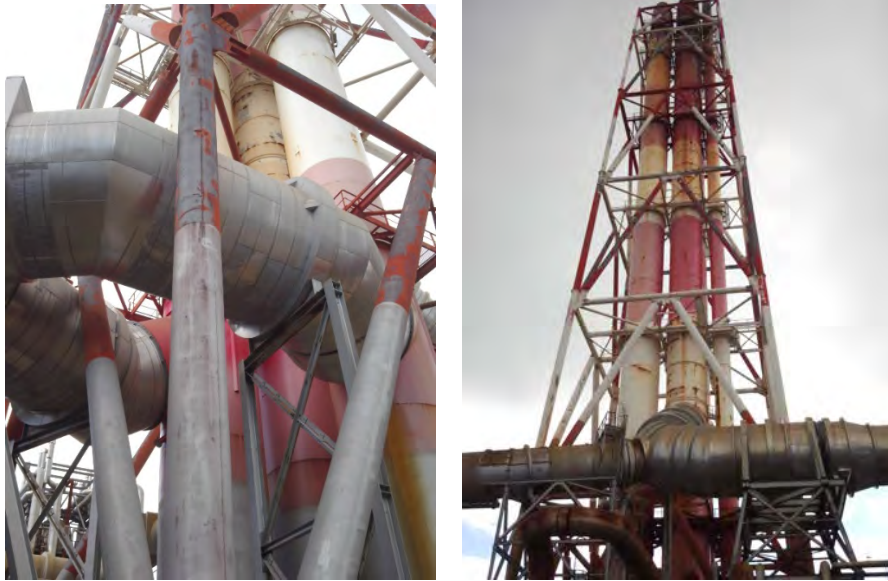
- The largest flue is 4.15m in internal diameter while the smallest is 1.8m.

Figure 16: C-Block Multi-flue.

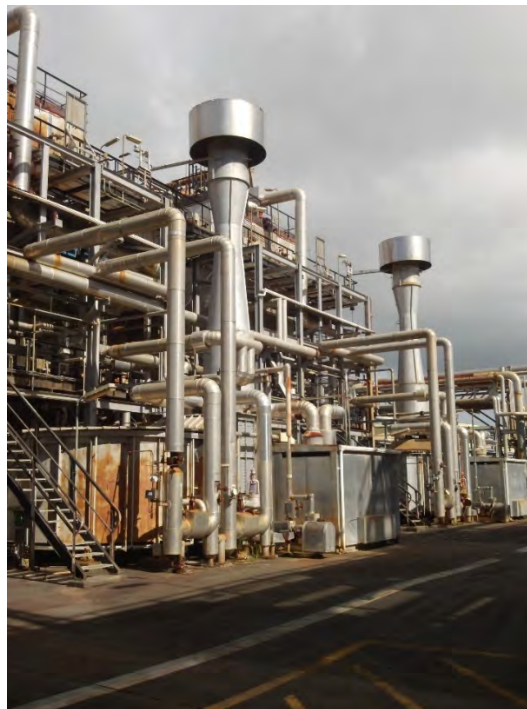
The steam system was supplied by several sources including waste heat boilers in C and E-block. However, the primary source of steam was three large, fired boilers in the utilities area of B-block, each produced 1950 Tonnes of superheated steam per day. The boilers were originally installed in the 1980's expansion and were intended to be installed within a boiler house which was never installed. The boilers were suffering from significant amounts of corrosion, and it is believed that if recommissioning was to proceed new boilers would be required.

Figure 17: Two of the Three Steam Boilers in B-Block

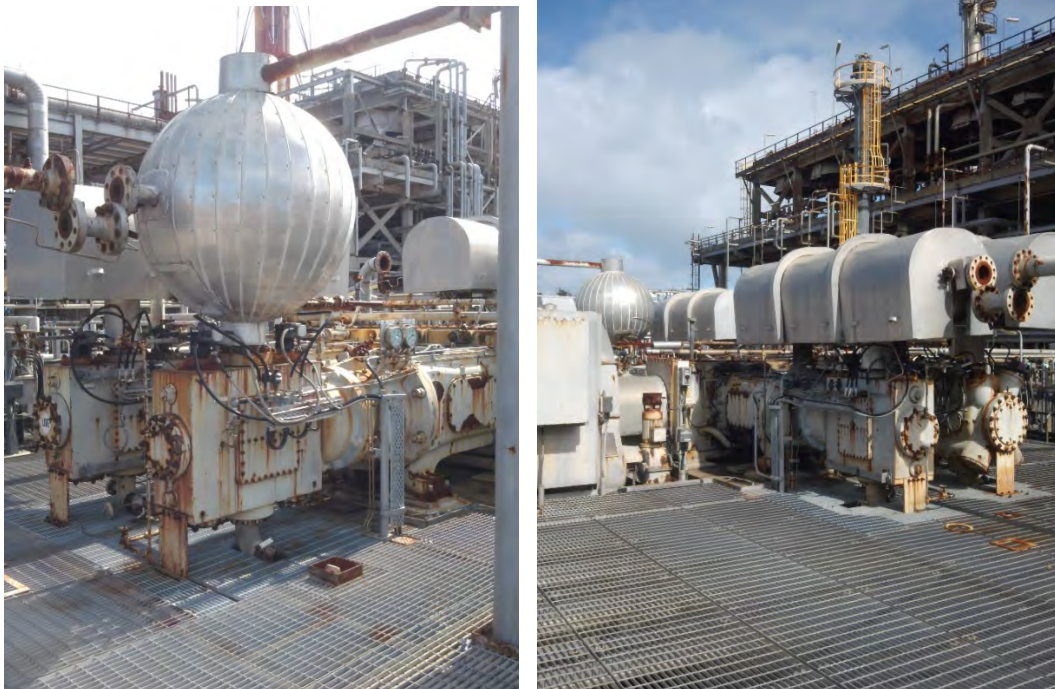
Figure 18: Four Stage Reciprocating Hydrogen Compressors

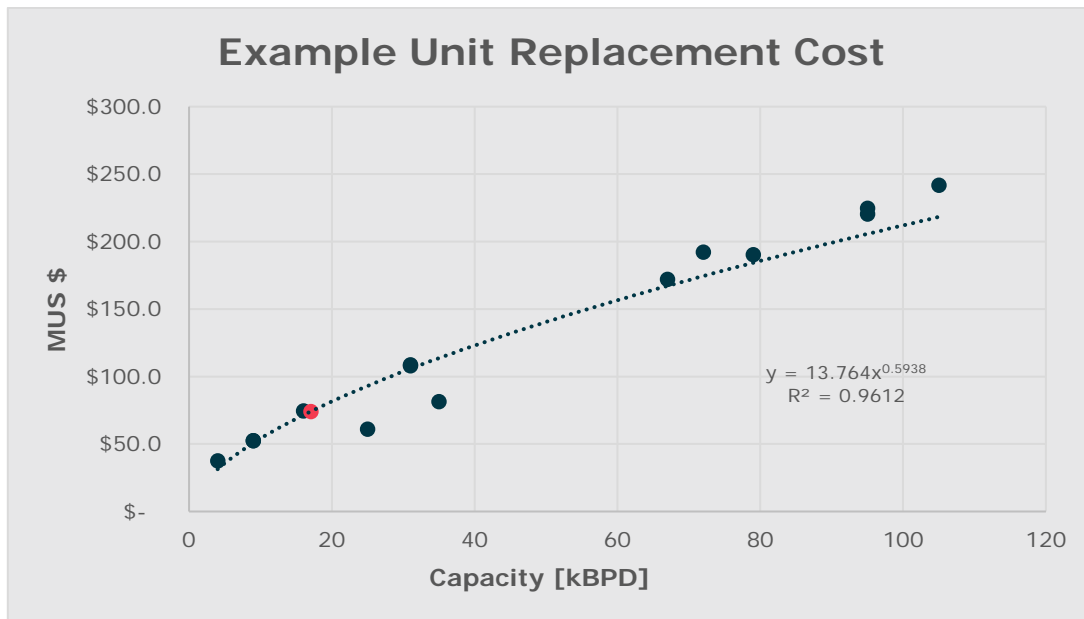
Replacement cost (excluding contingency) for the main process units have been determined based on the process unit name plate capacity. A cost curve per process unit has been developed from historical cost data by the Worley Houston team and plotted against capacity. For context, an example of a unit cost curve developed by Houston is provided below. This example demonstrates a total of 14 historical cost estimates across a range of nameplate capacities from four through to 105kBPD. The subject unit is shown as the orange data point.

Figure 19: An example Cost Curve Developed by Worley Houston for one of the Key Refinery Process Units

Reference costs have been escalated and normalized for currency, base date, region and applicability to a United States Gulf Coast in 2024 United States dollars. Costs were scaled on process unit capacity using parametric methods.
